NEW MEXICO ENVIRONMENT DEPARTMENT

**Re: Desert Mountain Transportation, Inc. dba Desert Mountain Corporation; Kirtland, New Mexico;
Unpermitted MSGP; SIC 4213/NAICS 484121; Compliance Evaluation Inspection; NPDES
Tracking No. NMU001932; April 6, 2017**

NPDES Compliance Inspection Report

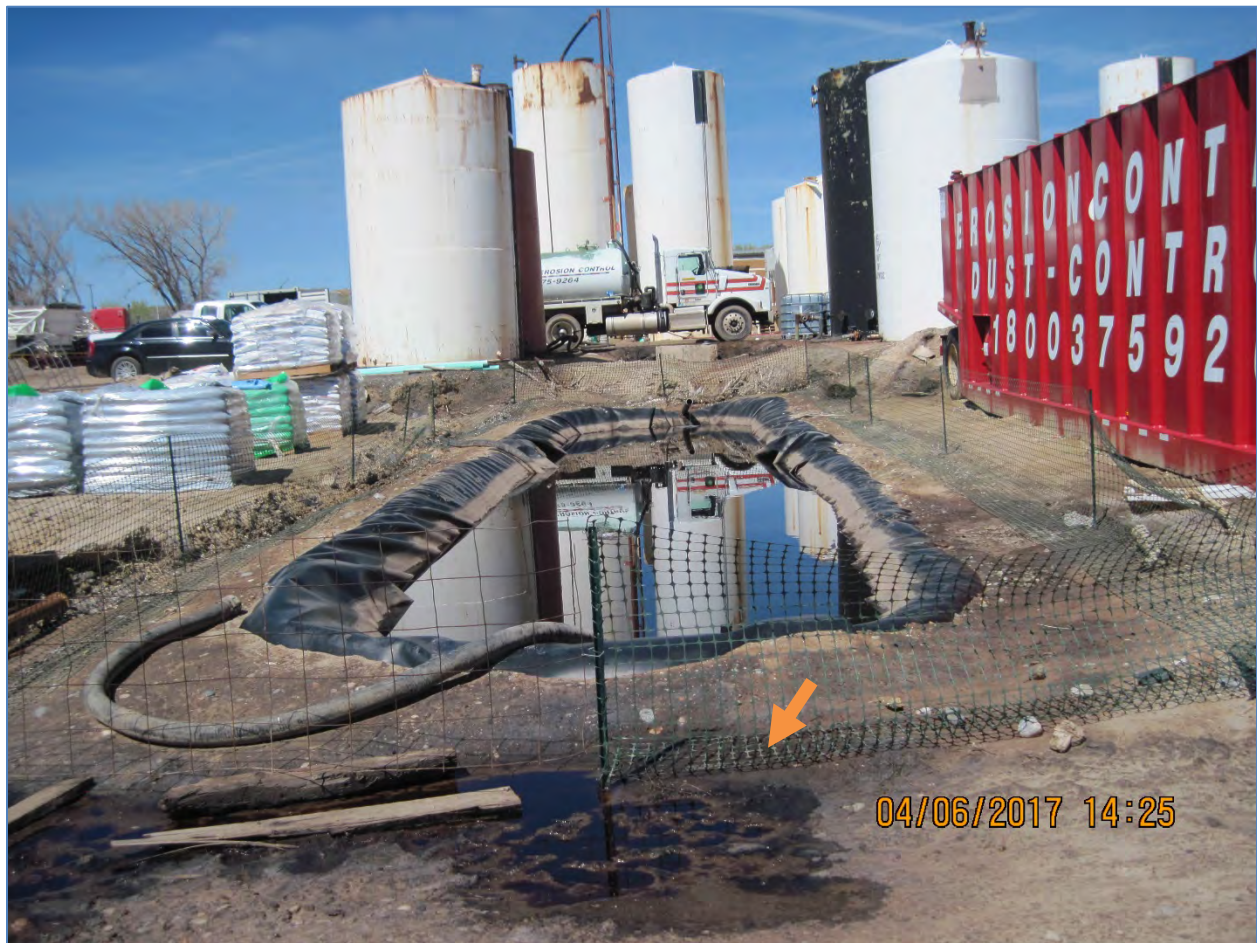
<p align="center">NMED/SWQB Official Photograph Log Photo # 16</p>		
Photographer: Erin S. Trujillo	Date: 04/06/2017	Time: 1425 hours
City/County: Kirtland, New Mexico / San Juan County		State: New Mexico
Location: Desert Mountain Corporation		
Subject: Looking north, liquids in lined pit were described by operator representative to be reused or recycled in blended products. Arrow points to dark brown liquid outside and adjacent to lined pit.

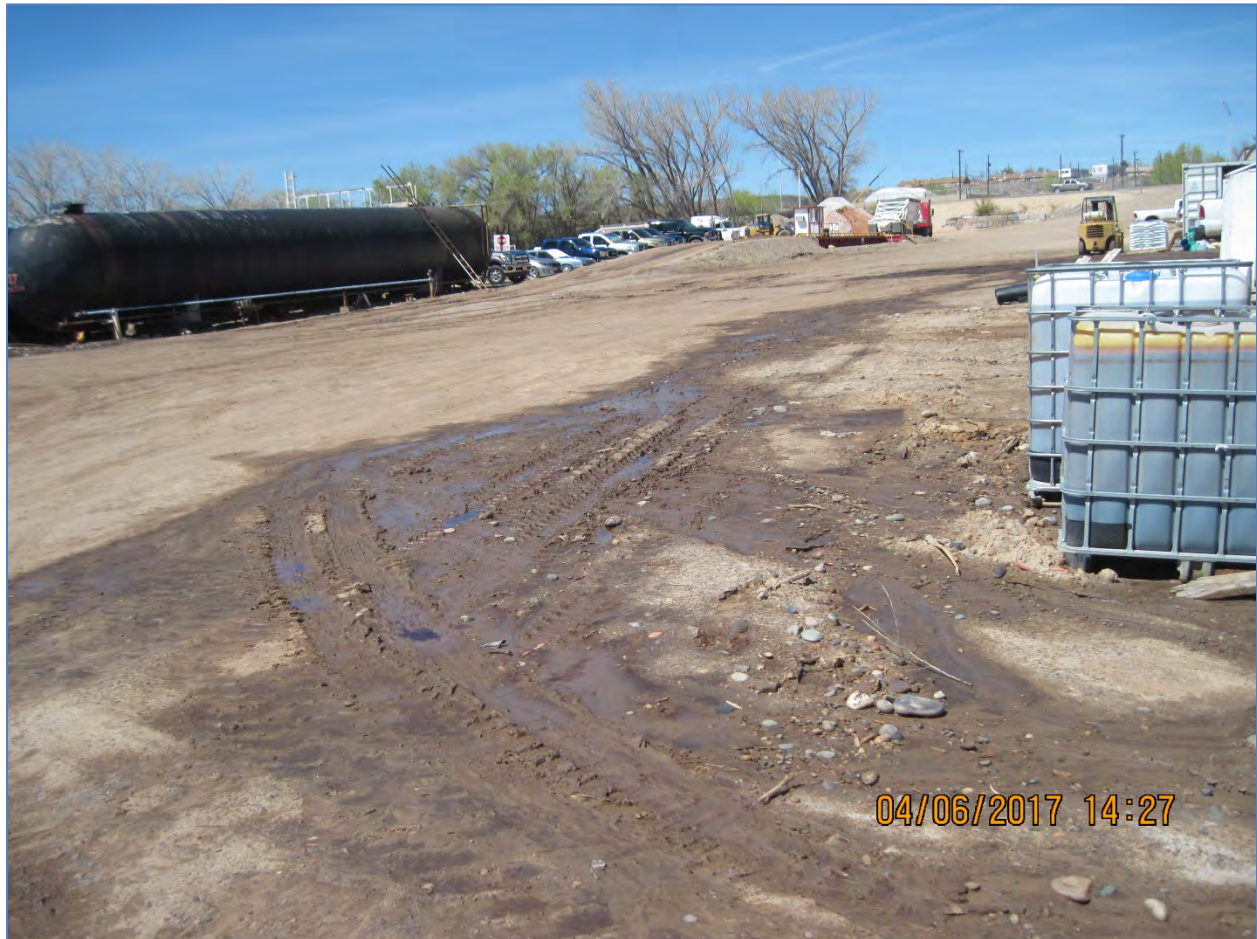
NMED/SWQB Official Photograph Log Photo # 17		
Photographer: Erin S. Trujillo	Date: 04/06/2017	Time: 1427 hours
City/County: Kirtland, New Mexico / San Juan County		State: New Mexico
Location: Desert Mountain Corporation		
Subject: Wet soils and dark brown liquid in equipment traffic area existed south and west of the product loading area.

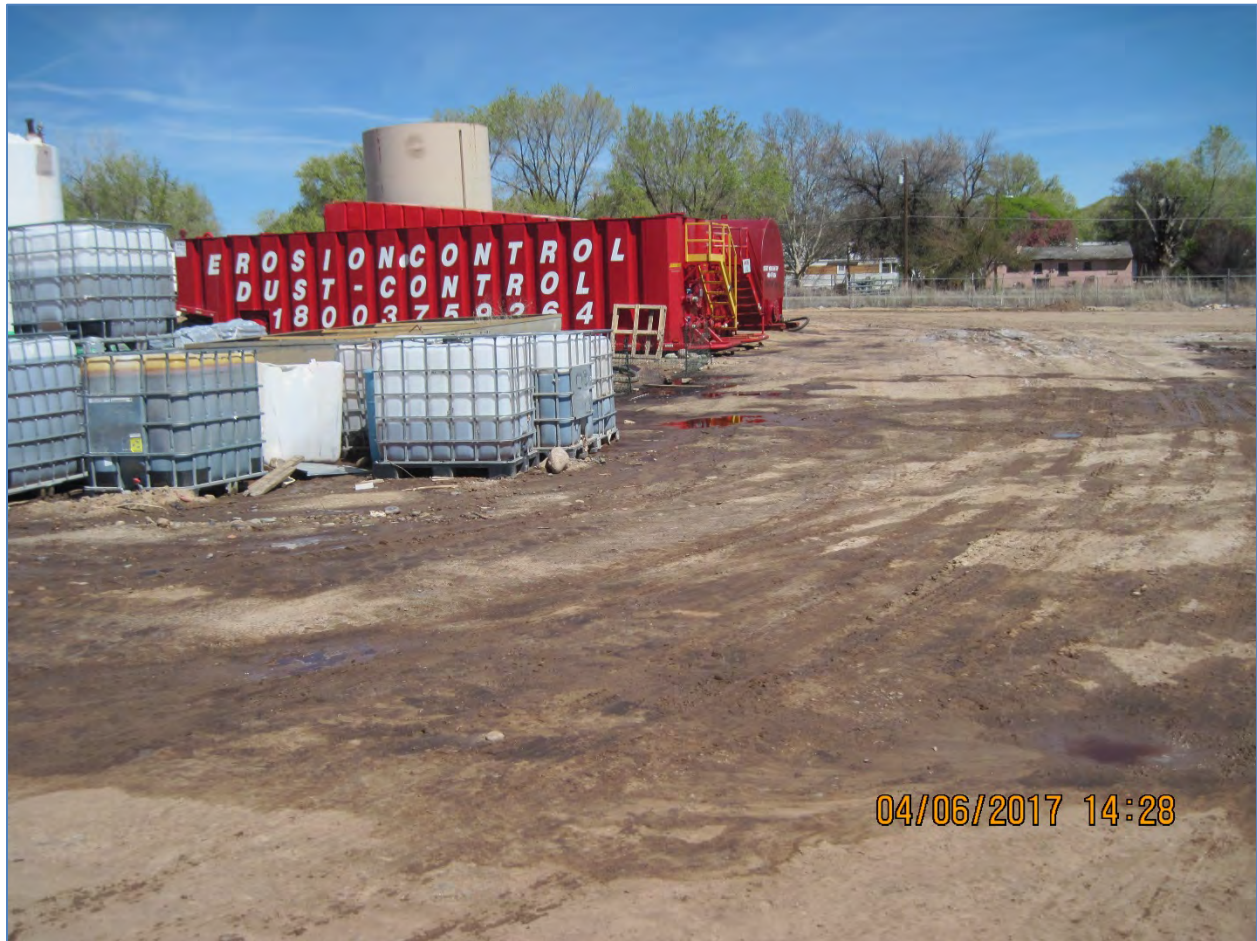
NMED/SWQB		
Official Photograph Log		
Photo # 18		
Photographer: Erin S. Trujillo	Date: 04/06/2017	Time: 1428 hours
City/County: Kirtland, New Mexico / San Juan County		State: New Mexico
Location: Desert Mountain Corporation		
Subject: Example of tote and fac tank product storage. Wet soils and dark brown liquid in traffic area existed south of the product loading area.

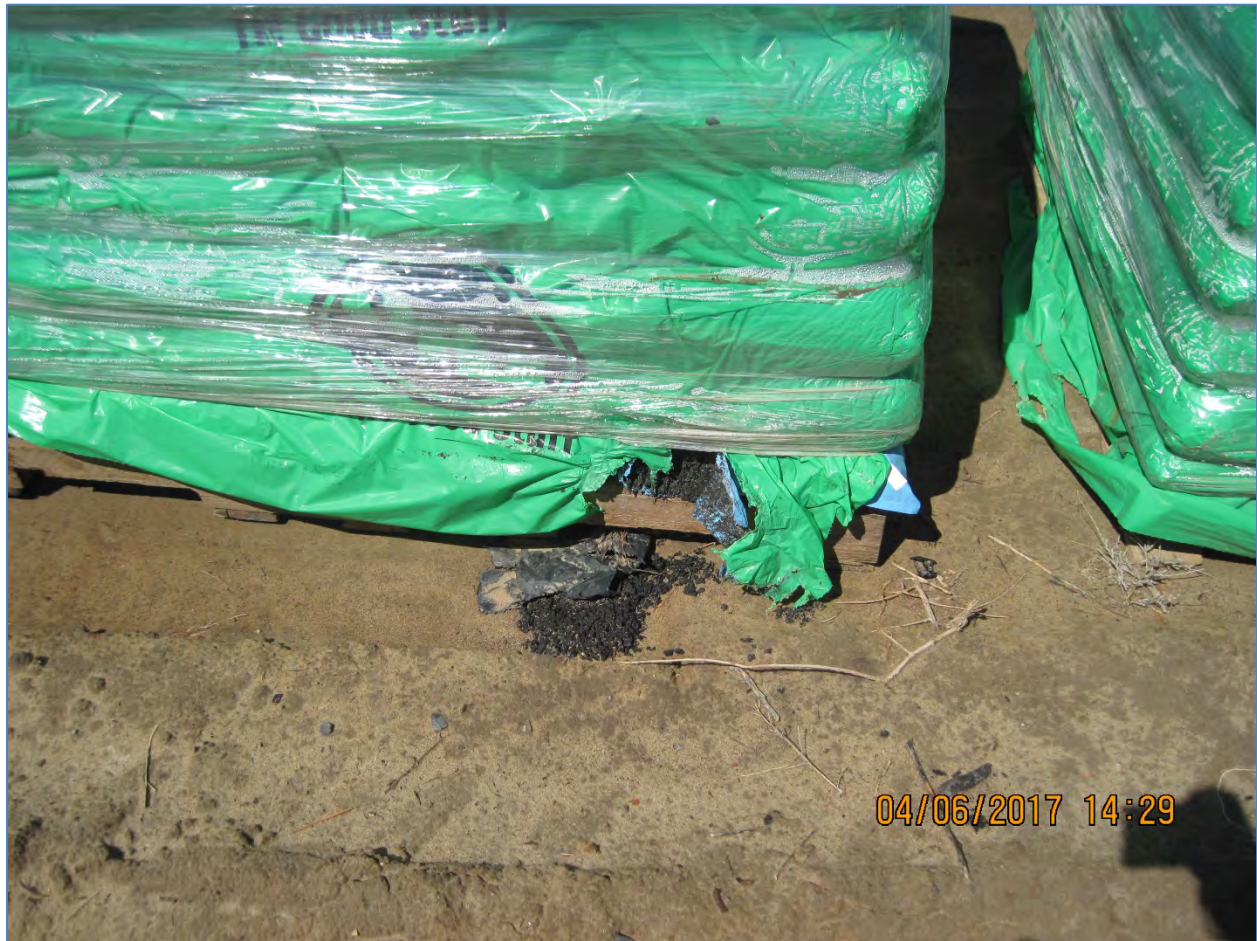
NMED/SWQB		
Official Photograph Log		
Photo # 19		
Photographer: Erin S. Trujillo	Date: 04/06/2017	Time: 1429 hours
City/County: Kirtland, New Mexico / San Juan County		State: New Mexico
Location: Desert Mountain Corporation		
Subject: In central portion of site, asphalt material was on ground below a broken bag stored on wooden pallet.

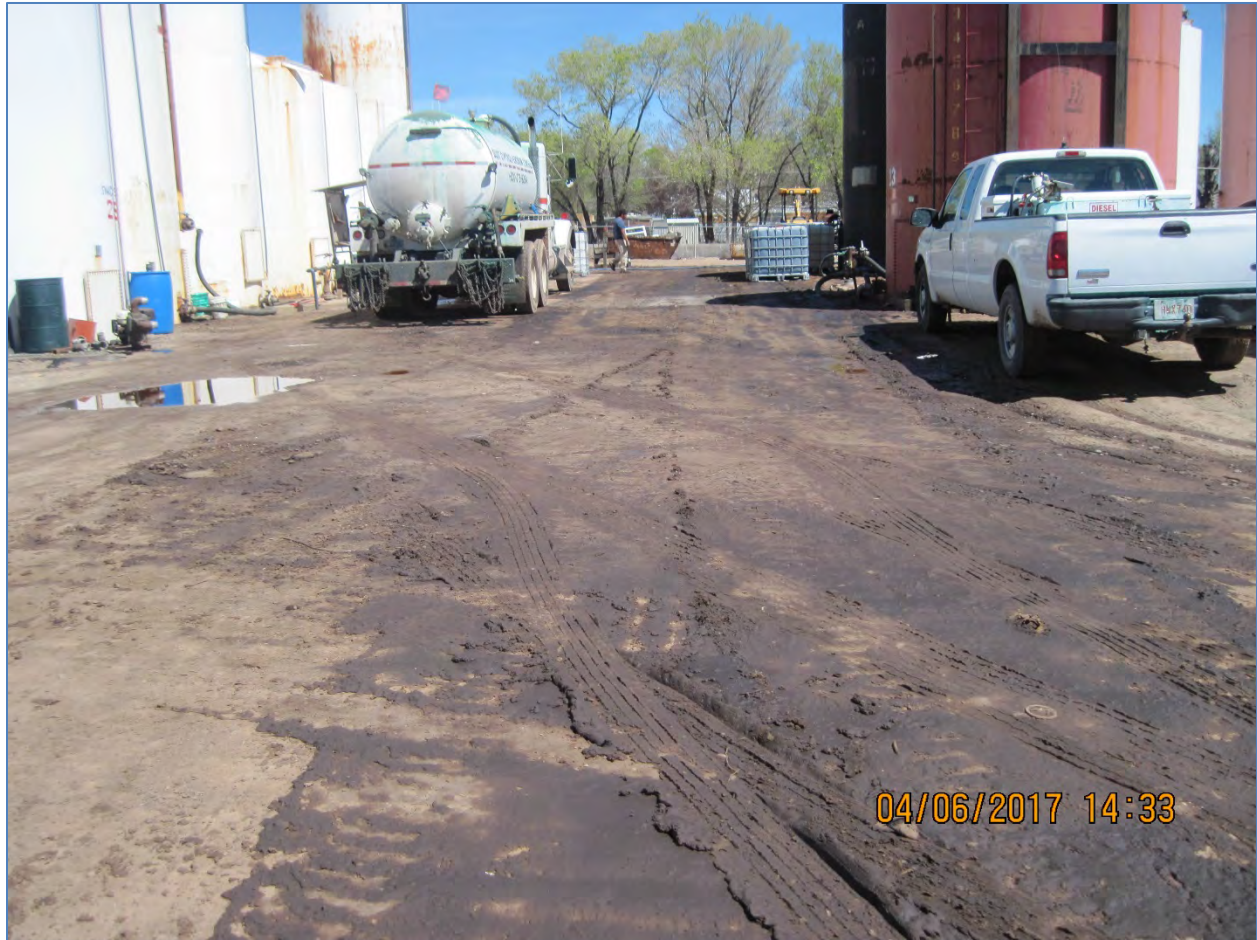
NMED/SWQB Official Photograph Log Photo # 20		
Photographer: Erin S. Trujillo	Date: 04/06/2017	Time: 1433 hours
City/County: Kirtland, New Mexico / San Juan County		State: New Mexico
Location: Desert Mountain Corporation		
Subject: Product loading area in central portion of site. Wet soils, dark brown lignin polymer and dark brown liquid existed in loading area.

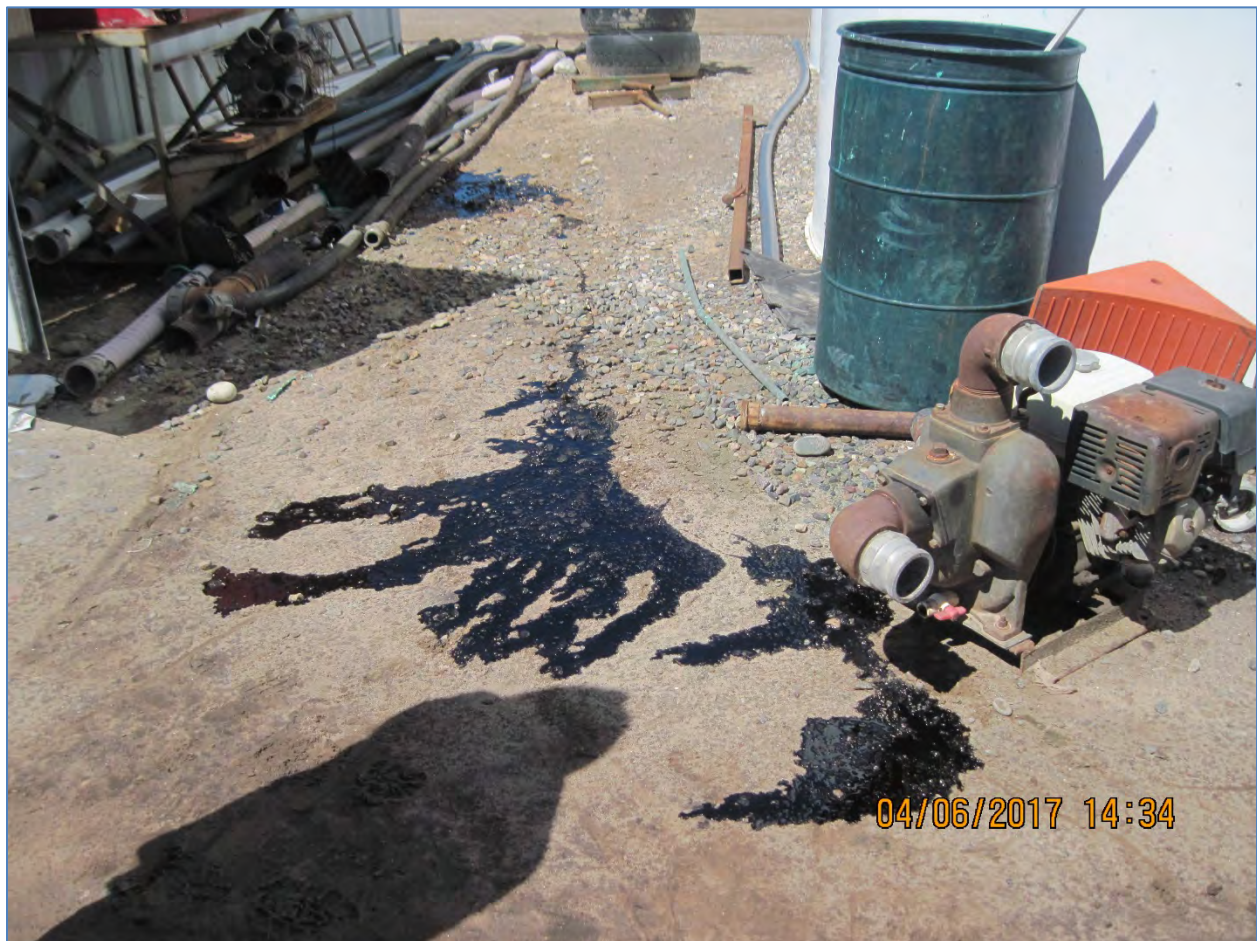
NMED/SWQB		
Official Photograph Log		
Photo # 21		
Photographer: Erin S. Trujillo	Date: 04/06/2017	Time: 1434 hours
City/County: Kirtland, New Mexico / San Juan County		State: New Mexico
Location: Desert Mountain Corporation		
Subject: Example of equipment and dark liquid near product loading tanks.

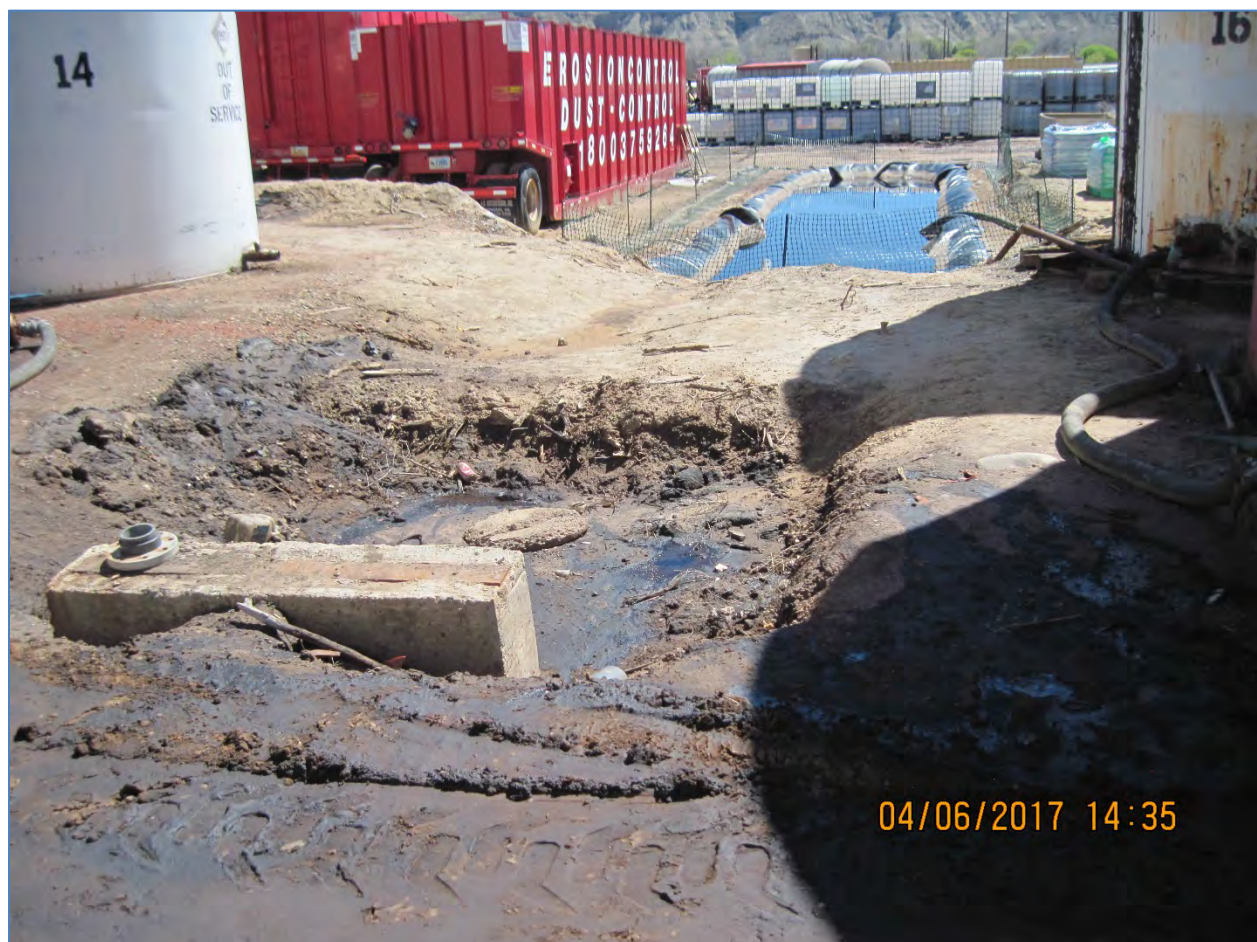
<p align="center">NMED/SWQB Official Photograph Log Photo # 22</p>		
Photographer: Erin S. Trujillo	Date: 04/06/2017	Time: 1435 hours
City/County: Kirtland, New Mexico / San Juan County		State: New Mexico
Location: Desert Mountain Corporation		
<p>Subject: Looking south in central portion of site from product loading area, excavated pit is in foreground and lined pit previously shown in early photo is in background. Vehicle maintenance shop floor drains are connected to the excavated pit (photos below) and equipment, product tank cleaning or draining flows to the unlined pit then lined pit shown in background according to operator representatives. Operator representative did not know last time solids in pits were removed.</p>

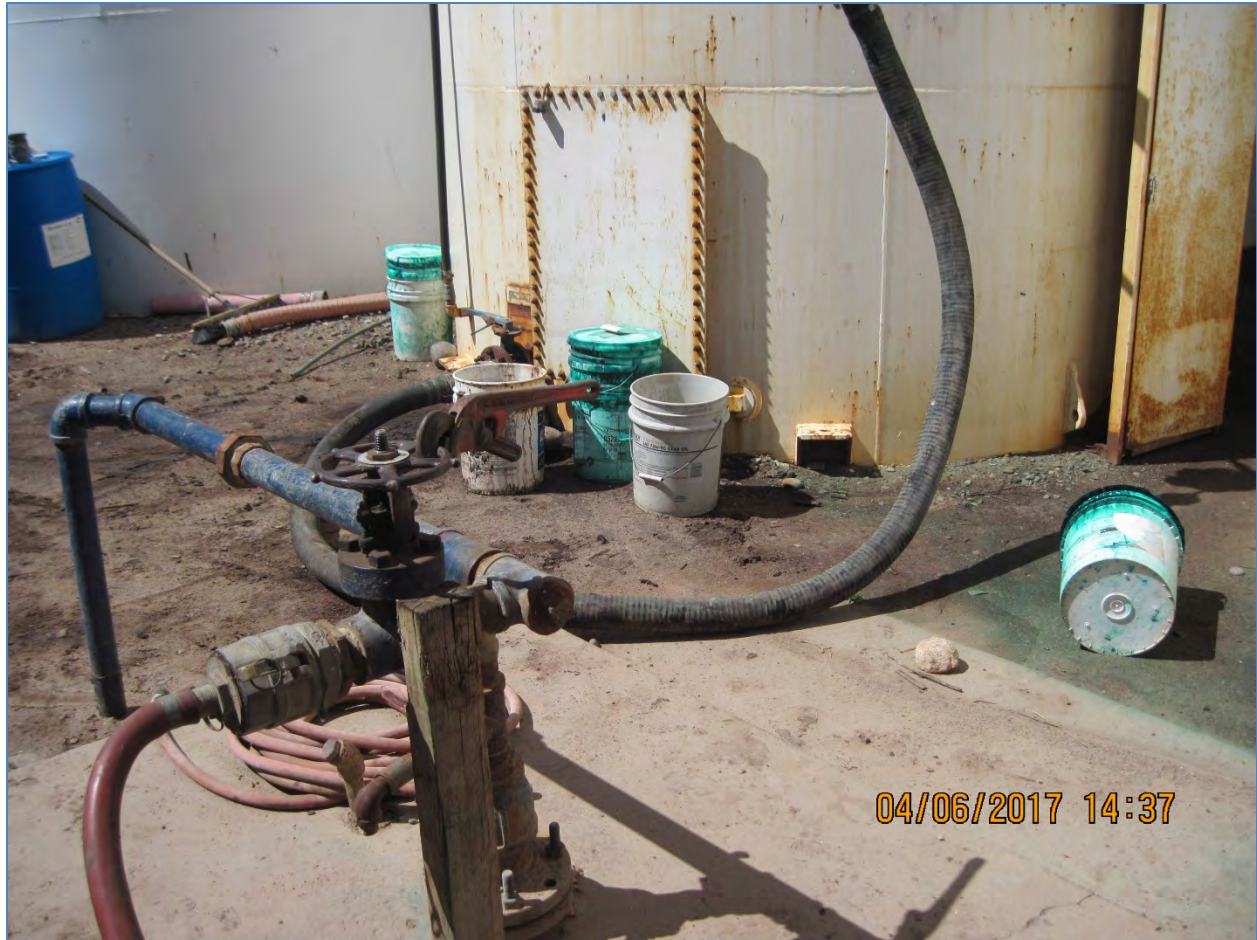
NMED/SWQB Official Photograph Log Photo # 23		
Photographer: Erin S. Trujillo	Date: 04/06/2017	Time: 1437 hours
City/County: Kirtland, New Mexico / San Juan County		State: New Mexico
Location: Desert Mountain Corporation		
Subject: From central portion of site, blue-green staining on buckets and ground at product loading area.

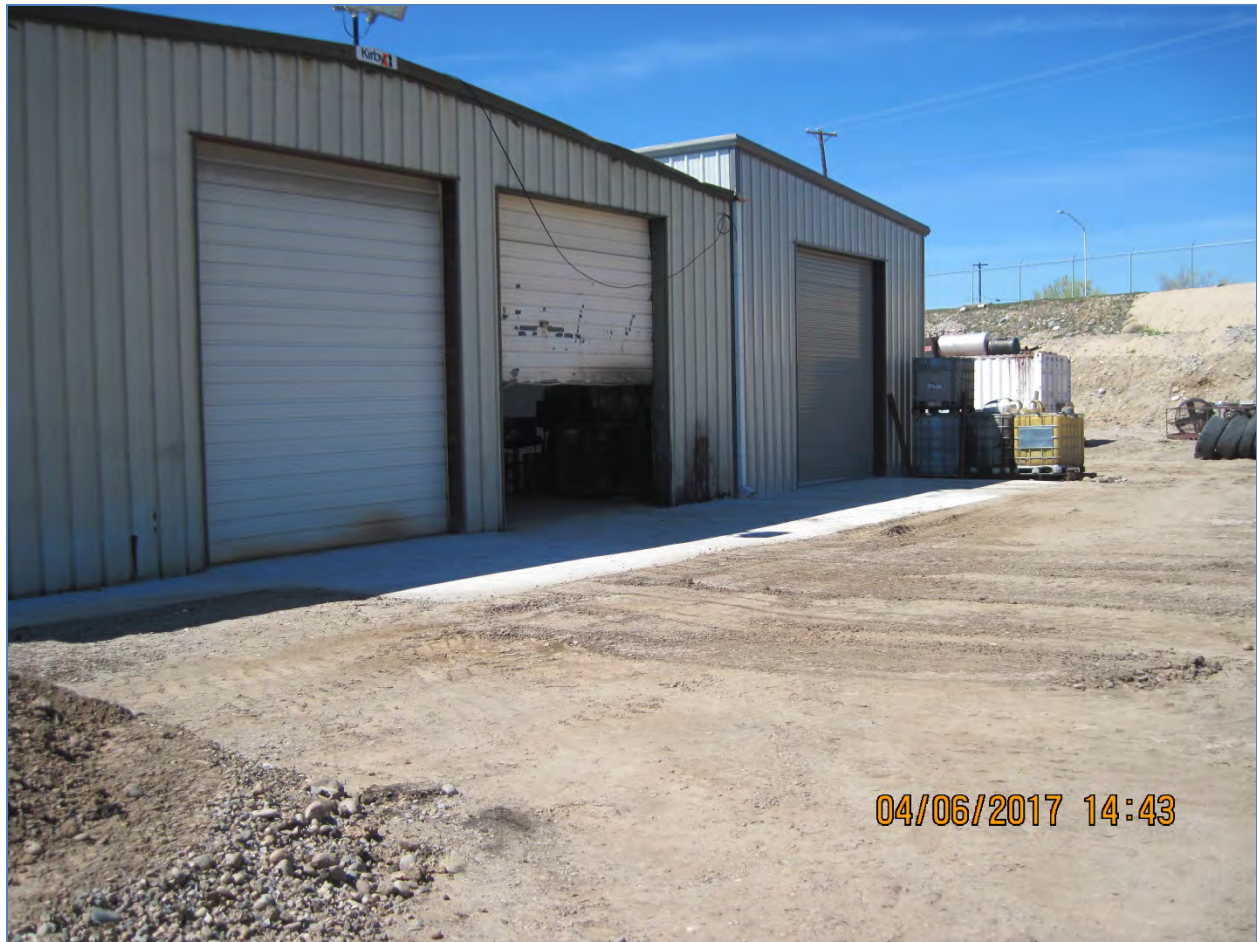
NMED/SWQB		
Official Photograph Log		
Photo # 24		
Photographer: Erin S. Trujillo	Date: 04/06/2017	Time: 1443 hours
City/County: Kirtland, New Mexico / San Juan County		State: New Mexico
Location: Desert Mountain Corporation		
Subject: From northeast corner of site, vehicle maintenance, tires and product storage in totes exist near northern property boundary.

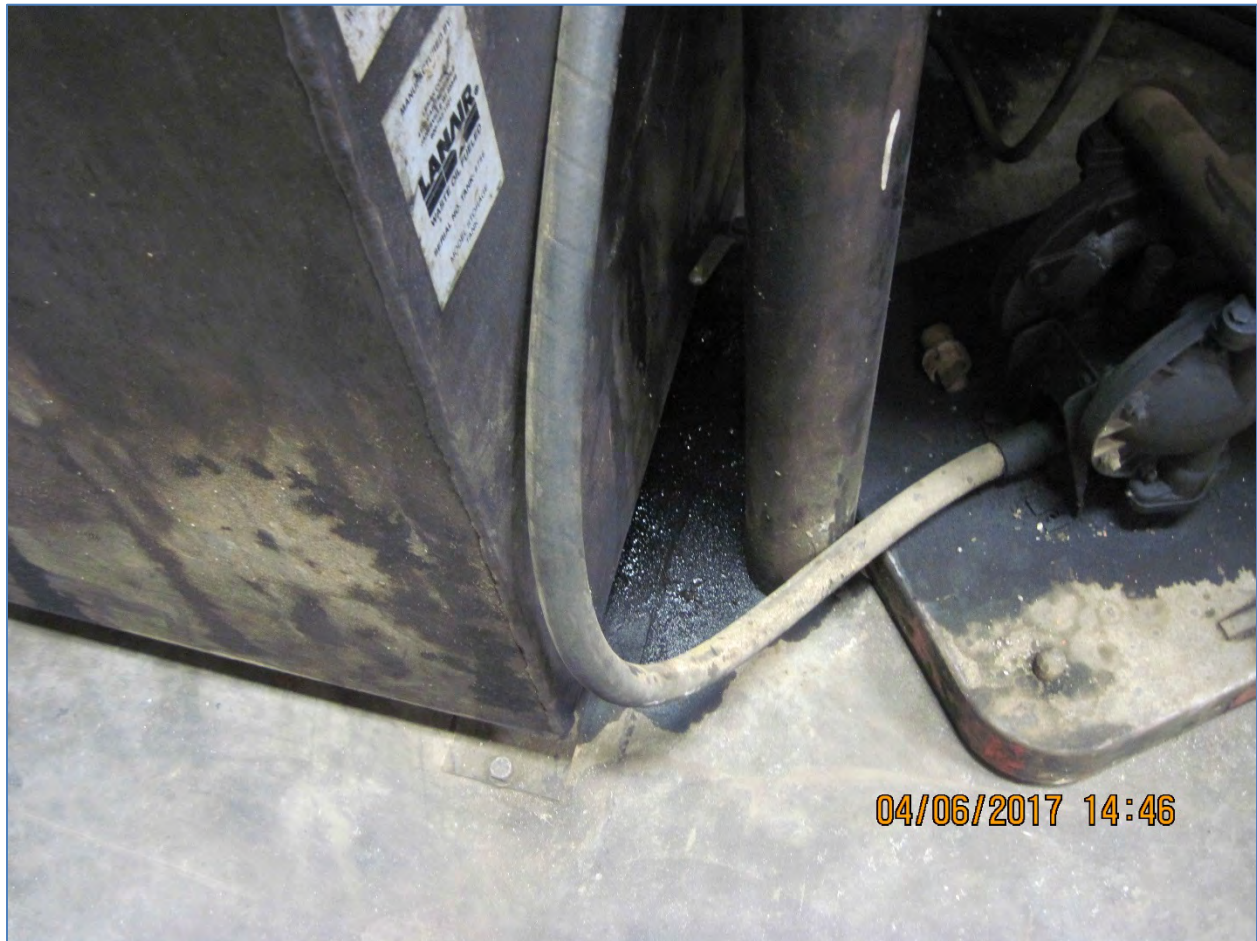
NMED/SWQB		
Official Photograph Log		
Photo # 25		
Photographer: Erin S. Trujillo	Date: 04/06/2017	Time: 1446 hours
City/County: Kirtland, New Mexico / San Juan County		State: New Mexico
Location: Desert Mountain Corporation		
Subject: Vehicle maintenance shop floors were relatively clean, except for a couple areas. This example of oily dark staining was below the parts cleaner and associated equipment.

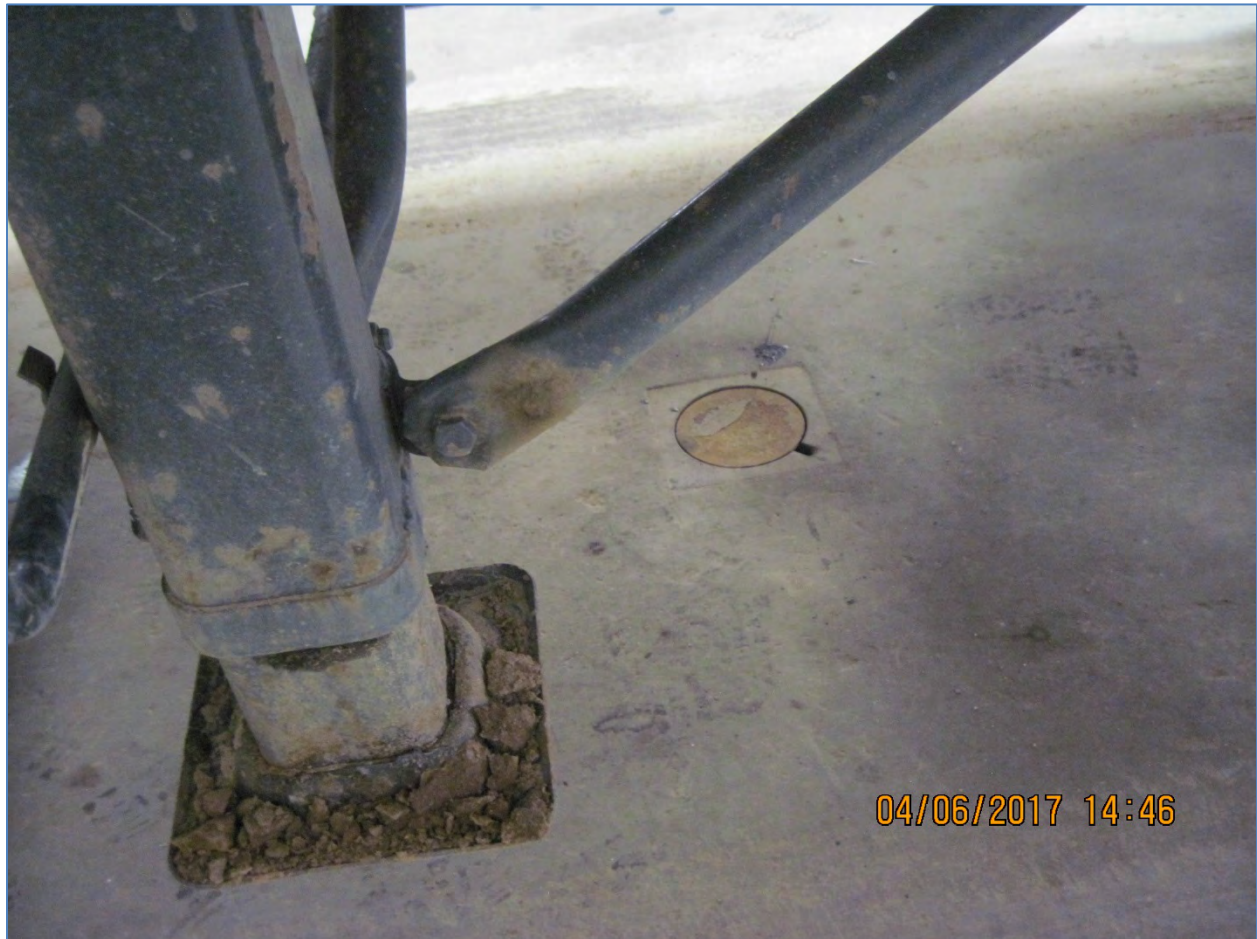
<p align="center">NMED/SWQB Official Photograph Log Photo # 26</p>		
Photographer: Erin S. Trujillo	Date: 04/06/2017	Time: 1446 hours
City/County: Kirtland, New Mexico / San Juan County		State: New Mexico
Location: Desert Mountain Corporation		
Subject: One of two floor drains in vehicle maintenance shop. According to operator representatives, drains had removable lids and maintenance shop bay floor wash wastewater is sent down the drains that are connected (plumbed) to the outside excavated pit shown in Photo #22.

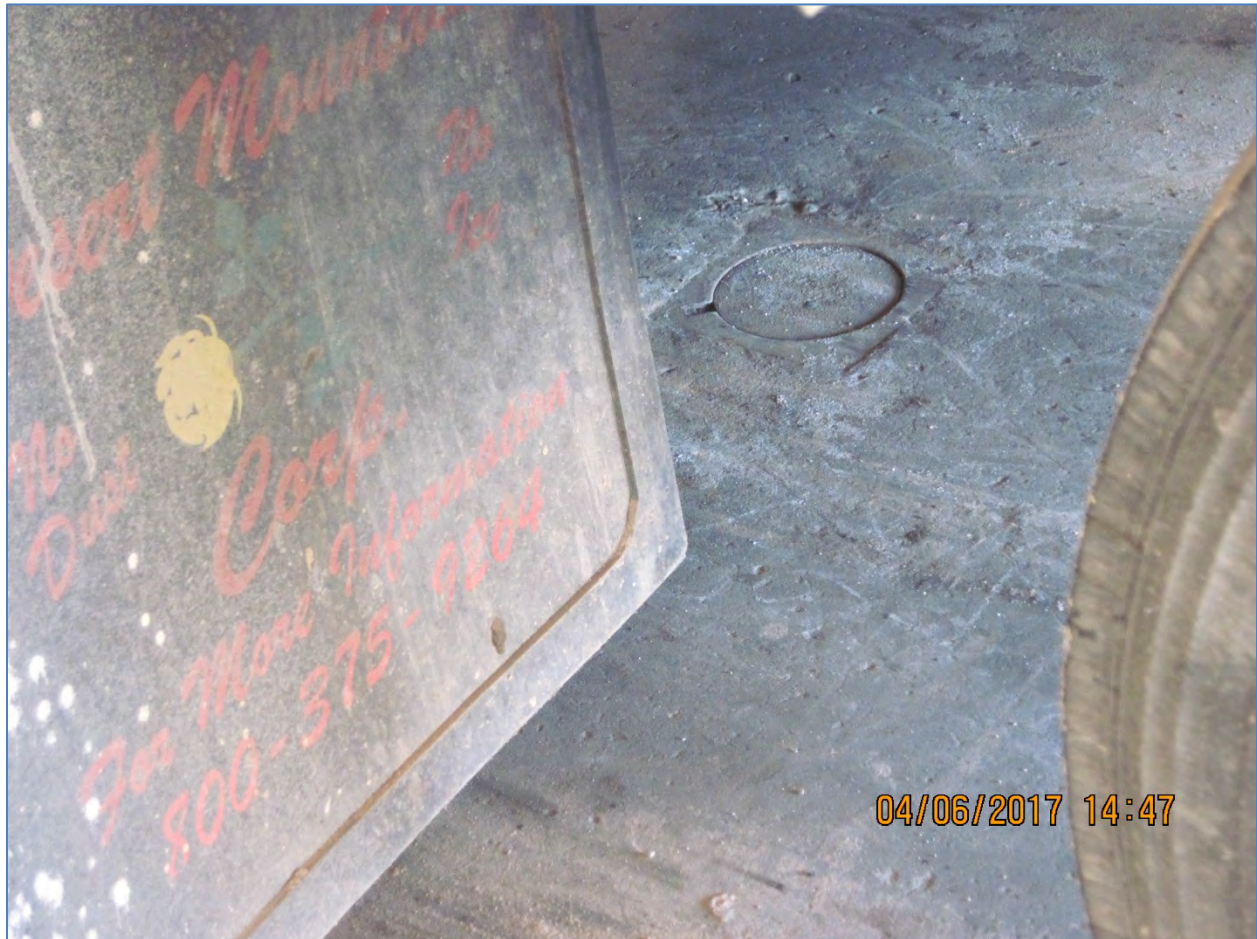
NMED/SWQB		
Official Photograph Log		
Photo # 27		
Photographer: Erin S. Trujillo	Date: 04/06/2017	Time: 1447 hours
City/County: Kirtland, New Mexico / San Juan County		State: New Mexico
Location: Desert Mountain Corporation		
Subject: One of two floor drains in vehicle maintenance shop. According to operator representatives, drains had removable lids and maintenance shop bay floor wash wastewater is sent down the drains that are connected (plumbed) to the outside excavated pit shown in Photo #22.

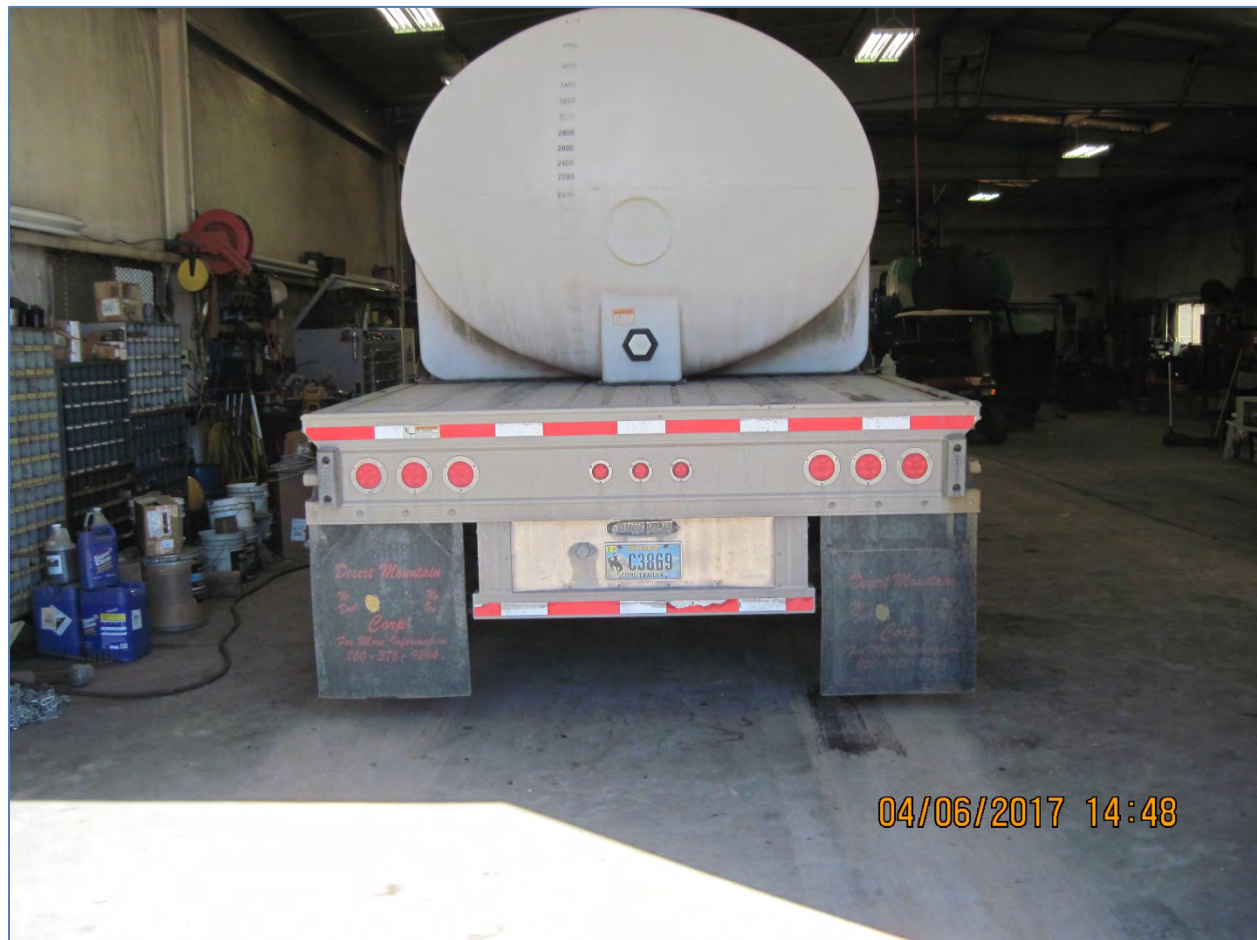
NMED/SWQB		
Official Photograph Log		
Photo # 28		
Photographer: Erin S. Trujillo	Date: 04/06/2017	Time: 1448 hours
City/County: Kirtland, New Mexico / San Juan County		State: New Mexico
Location: Desert Mountain Corporation		
Subject: Vehicle maintenance product storage and tanker inside vehicle maintenance shop bay.

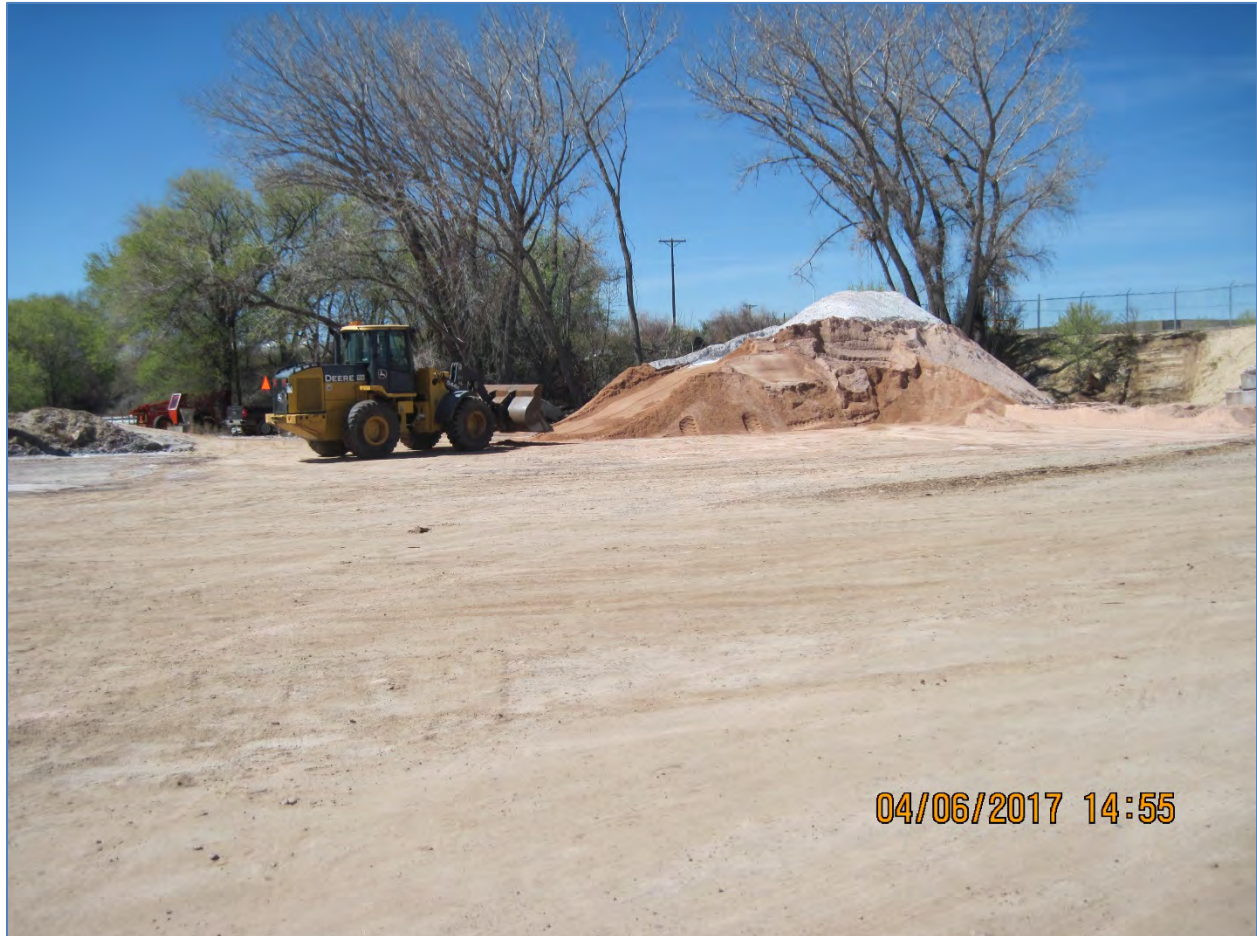
NMED/SWQB		
Official Photograph Log		
Photo # 29		
Photographer: Erin S. Trujillo	Date: 04/06/2017	Time: 1455 hours
City/County: Kirtland, New Mexico / San Juan County		State: New Mexico
Location: Desert Mountain Corporation		
Subject: Looking northwest, salt pile storage was located at northern property boundary near entrance.
